AIRCRAFT ACCIDENT REPORT

EXECUTIVE JET AVIATION, INC.

LEAR JET L23A, N434EJ

REPORT NUMBER: NTSB-AAR -71-3

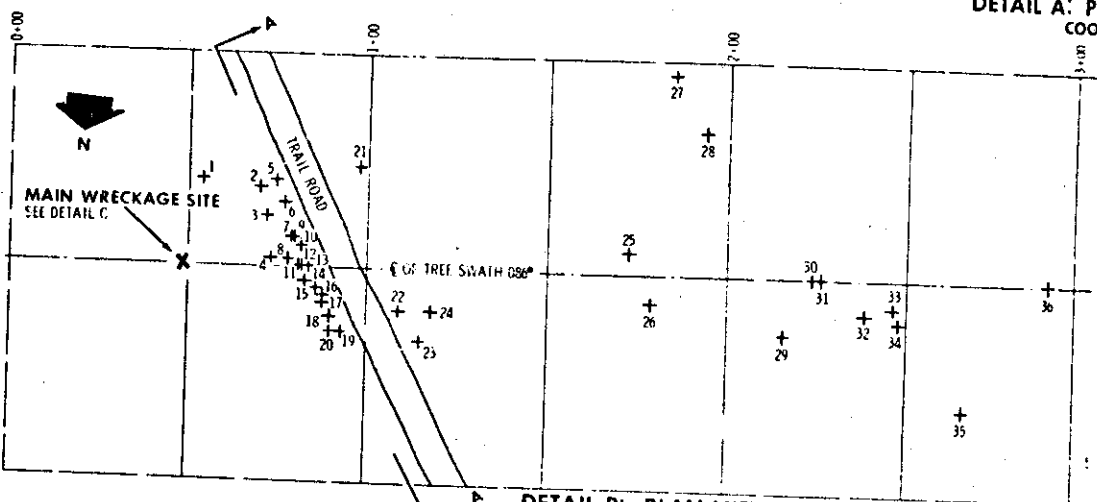
DETAIL B: PLAN VIEW OF FINAL IMPACT AREA
 COORDINATES 45°33'43" - 84°50'17"W

The aircraft remained airborne for approximately one-half mile, following initial tree impact, before striking trees again, after which the aircraft crashed to the ground and burned. The swath through the trees at the crash site was approximately 269 feet long on a true heading of 86° . The m.s.l. elevation at the highest point of tree contact in the crash area was 809 feet. The main wreckage was contained in a space approximately 80 feet wide and 130 feet long. The ground elevation at the crash site is 730 feet. The latitude is $45^{\circ}33'43''$ N. and the longitude is $84^{\circ}50'17''$ W.

The wreckage at the main impact site was confined to an area measuring approximately 130 feet by 50 feet. From cuts on the trees, the lateral attitude of the aircraft was determined to be approximately 37° left wing down. Similarly, the descending angle of the aircraft through the trees

was found to be approximately 16° . The main wreckage site is located approximately 1-3/4 statute miles from the threshold of Runway 5. For details of impact areas and wreckage distribution, see Attachment No. 1.

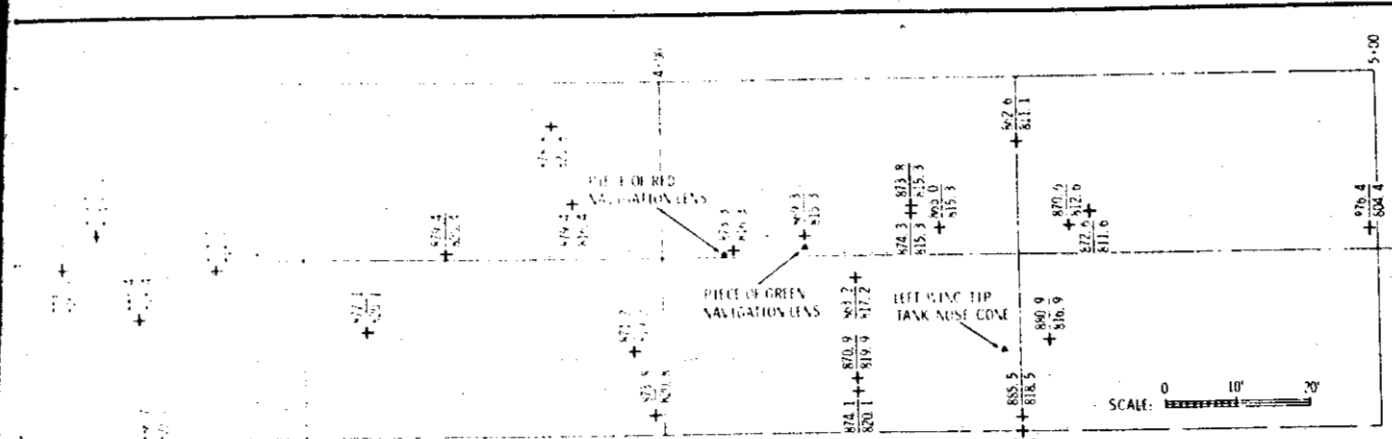
DETAIL A: PLAN VIEW OF INITIAL IMPACT AREA
 COORDINATES 45° 33' 43" N - 84° 51' 02" W

The aircraft made initial contact with trees on a hill located approximately $2\frac{1}{2}$ miles southwest of the approach end of Runway 5. A swath approximately 45 feet wide and 254 feet long, on a true heading of 107° , had been cut through the trees by the aircraft. The highest mean sea level (m.s.l.) elevation of the trees at the break points was 886 feet.

At the initial impact site, the path of the tree damage was 254 feet long and 45 feet wide. Within this area were found the red and green navigation light lenses, landing light lens, vortex generators, and the left wingtip fuel tank nose cone. None of the recovered pieces from this area revealed any evidence of fire. None of the vegetation in the area was burned.

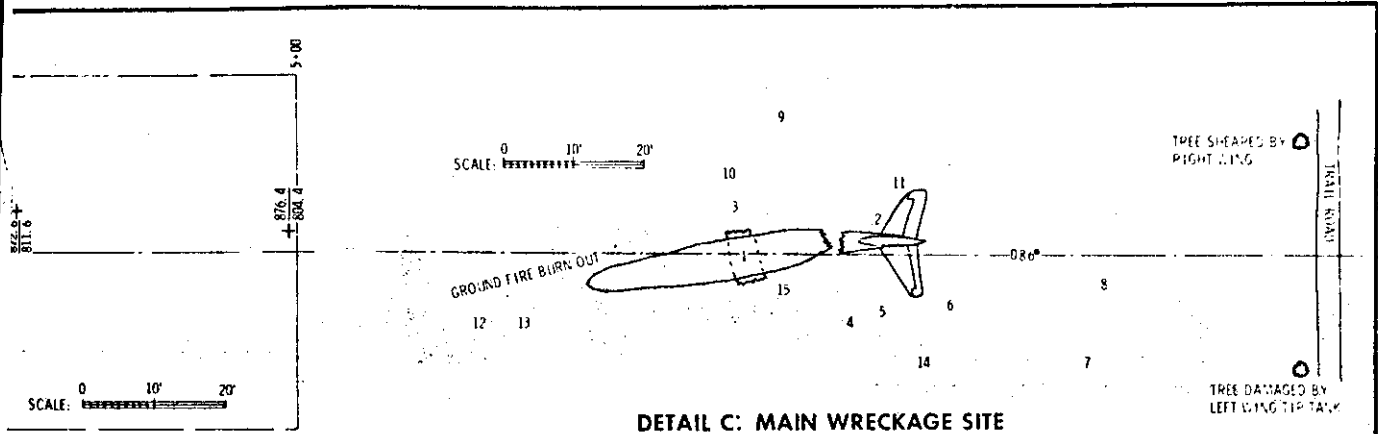
DETAIL C: MAIN WRECKAGE SITE

The intact, or nearly intact, sections were the avionics compartment; the right wing flap; and the after portion of the fuselage with the vertical stabilizer, rudder, horizontal stabilizer, and elevators attached. The avionics compartment, after fuselage, and empennage, were found in the upright position.
